Manhole Inspection Summary

Manhole # S29SS_020MH

Insp Date: **8/5/08 1:22 PM**

Location Address: **2800 FALLS RD**

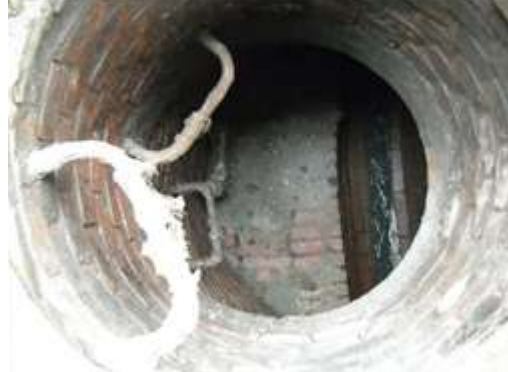
Top View

Corroded steps. Evidence of surcharge - Bench debris.

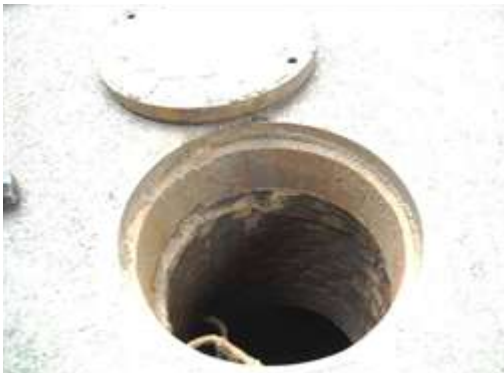
Defect

Frame leaks. Frame offset. Adjustment deterioration and infiltration. Corbel infiltration.

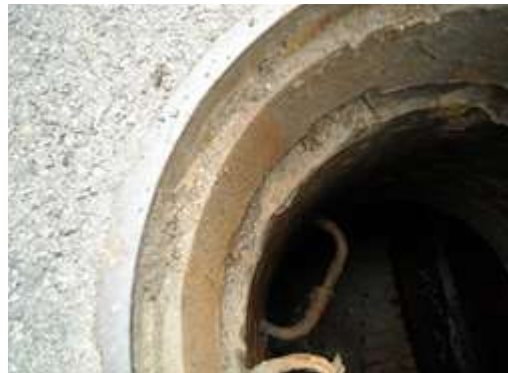
Defect

Frame leaks. Frame offset. Adjustment infiltration.

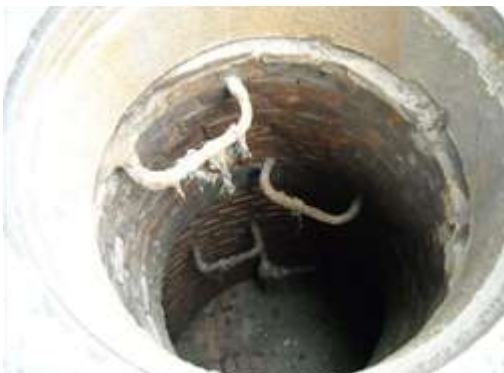
Defect

Frame leaks. Frame offset. Adjustment deterioration and infiltration. Corbel and Barrel infiltration.

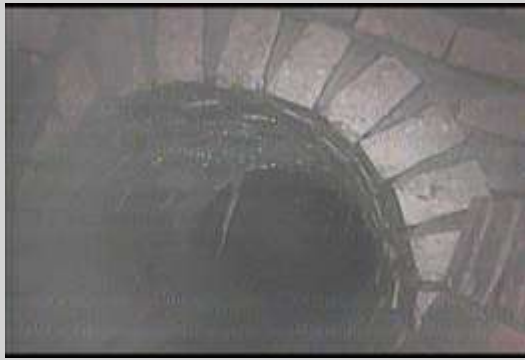
18 in. Circular Gravity Sewer Pipe Out @ 12 O'Clock

Infiltration: **Evidence** Pipe Seal Cond: **Unknown**
